Manhole Inspection Summary

Manhole # S67O__016MH

Insp Date: **2/7/08 1:29 PM**

Location Address: **6300 Boston St.**

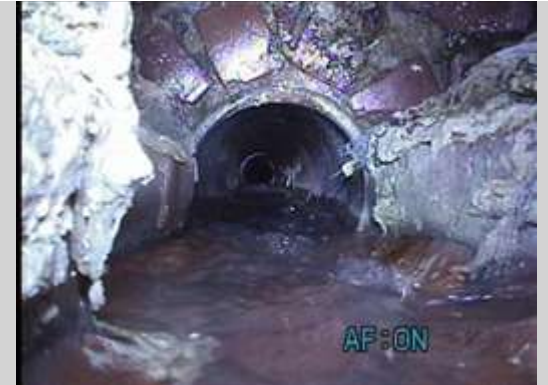
12 O'Clock Outflow

8 in. Circular Gravity Sewer
Pipe Out @ 12 O'Clock

Pipe Height: **8.4** (in.) Rod and Bar (Angled)
Pipe Material: **Clay** ☐ Pipe Lined
Invert Depth: **10.83** (ft.) Flow Characteristics: **Fast**
Deposits: ☒ None ☐ Mud ☐ Sludge ☐ Debris ☐ Grease
Silt Depth: (in.) Deposits Extent:
Infiltration: **None** Pipe Seal Cond: **Sound**

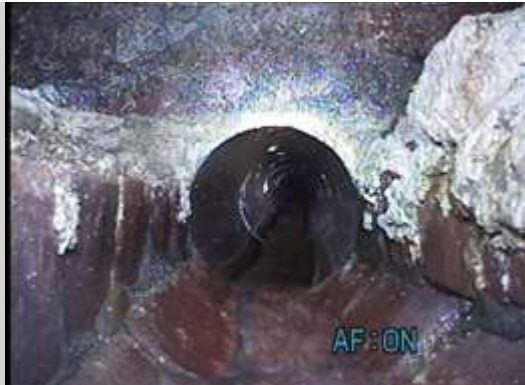
6 O'Clock Inflow

8 in. Circular Gravity Sewer

Pipe In @ 6 O'Clock

Pipe Height: **8.4** (in.) Rod and Bar (Angled)

Pipe Material: **Clay** ☐ Pipe Lined

Infiltration: **None** Pipe Seal Cond: **Sound**
